BARR ENGINEERING CO.
CONSULTING ENGINEERS

December 8, 1982

This letter summarizes the status of the hydrogeologic investigation of the former waste disposal site on the Henkel property and provides recommendations for further monitoring. The five new Platteville piezometers have been installed as recommended in our August 13, 1982 letter to General Mills. The locations of the new wells were moved slightly to avoid problems with utilities and at the request of property owners. The locations of the new piezometers are shown in Figure 1 accompanying this letter. As you know, the placement of the piezometers took much longer than expected (1-2 weeks per piezometer) due to the need to use 6-inch diameter casing and due to the bouldery drift that was encountered.

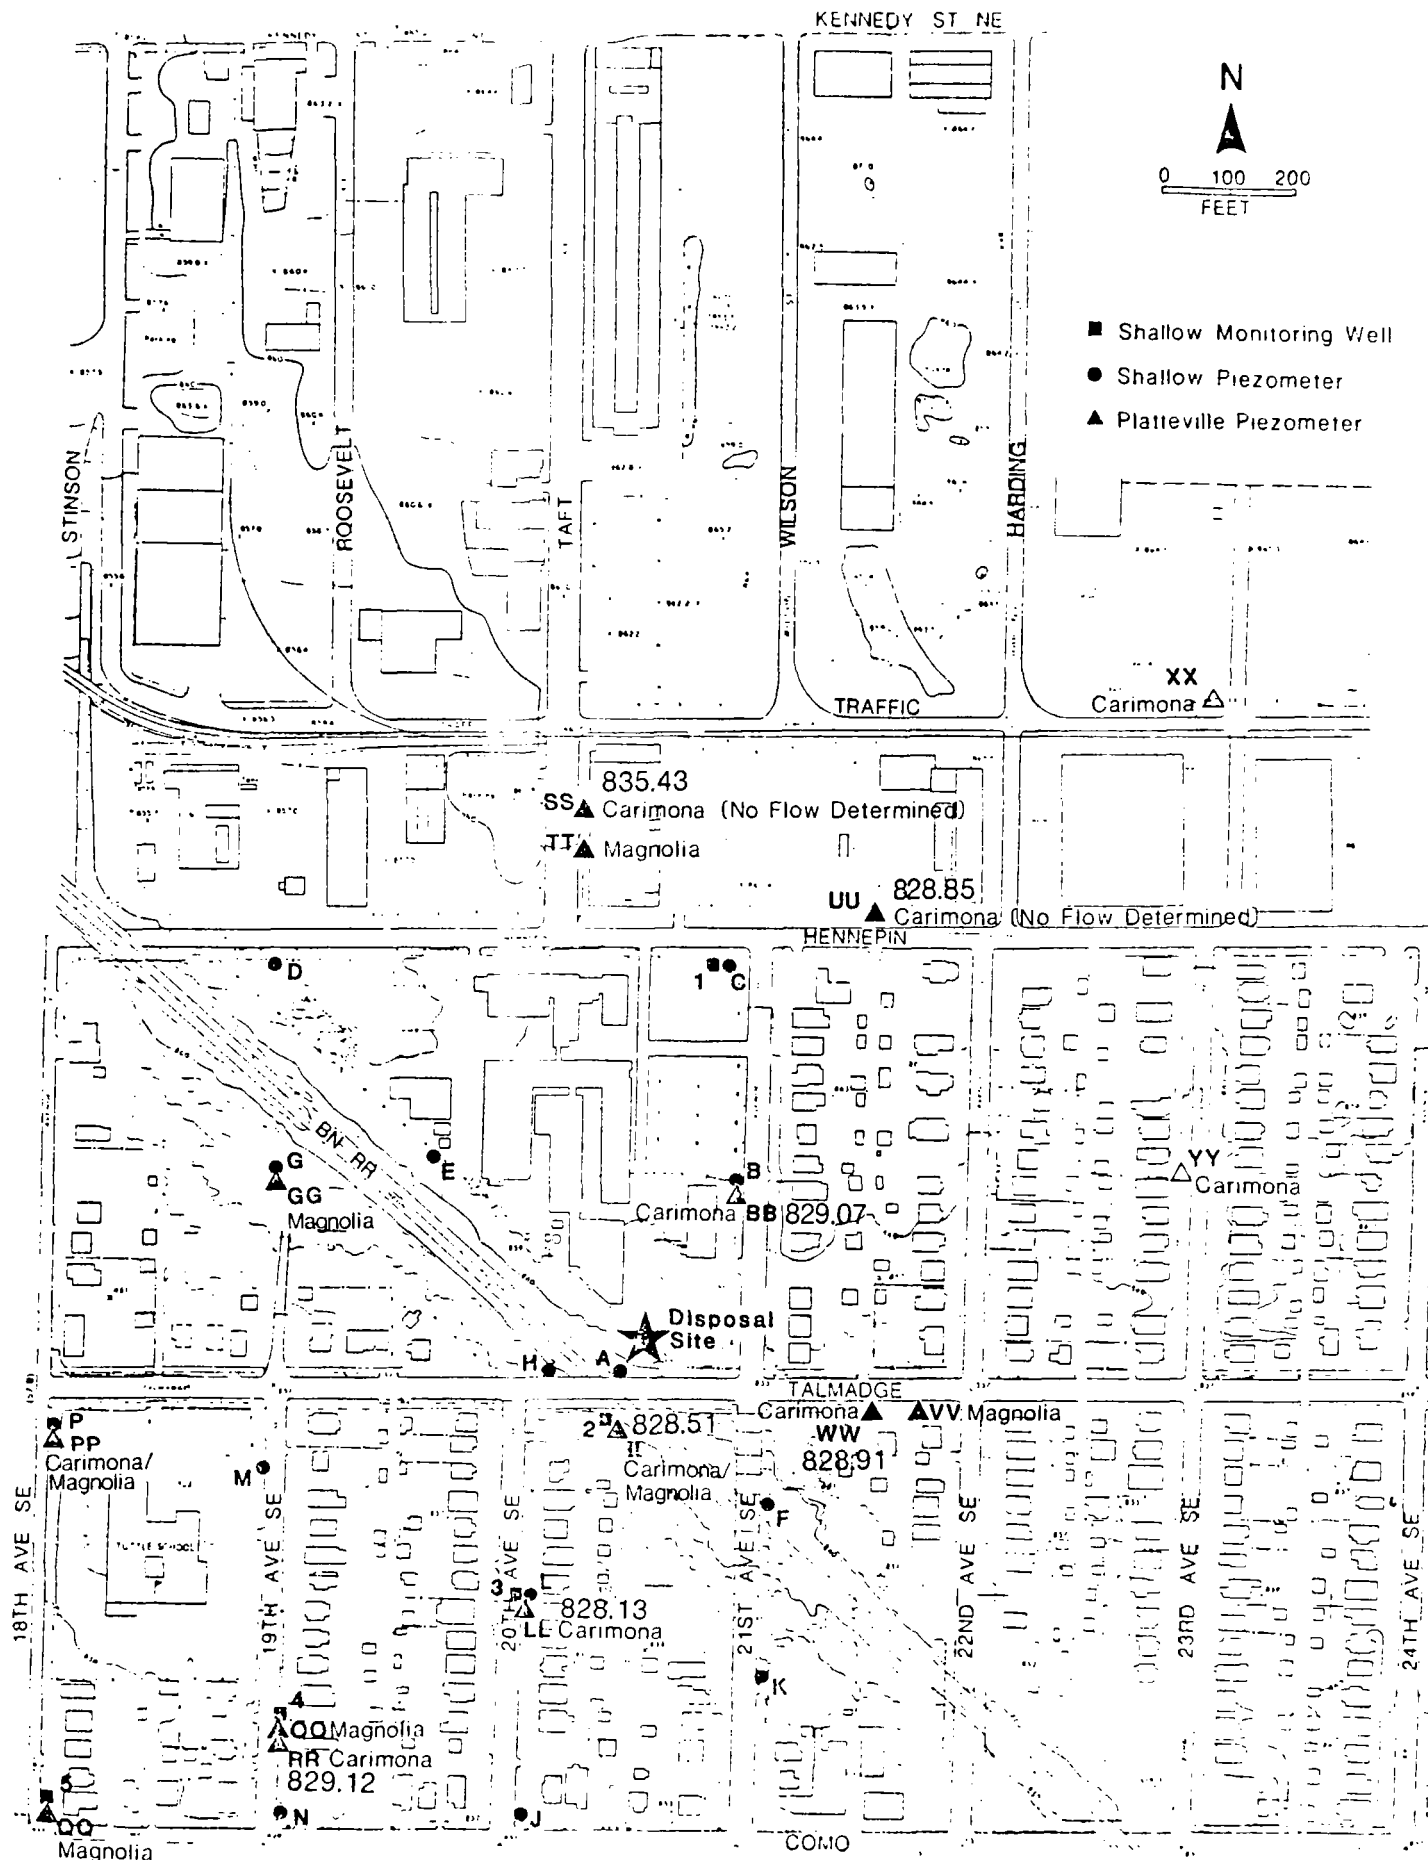
Figure 2

The data show that groundwater gradients are very flat in the Carimona Member of the Platteville. No flow could be discerned through Piezometers SS and UU using the Geoflow instrument. Groundwater levels are much more variable in the Magnolia Member. Flow measurements showed flow to the south-southwest at Piezometers TT and VV. Although this flow direction is not consistent with the gradients shown by the groundwater level measurements, it is likely that the flow in the Magnolia (as well as in the Carimona) is

WATER LEVELS (MSL)
CARIMONA MEMBER
(November, 1932)

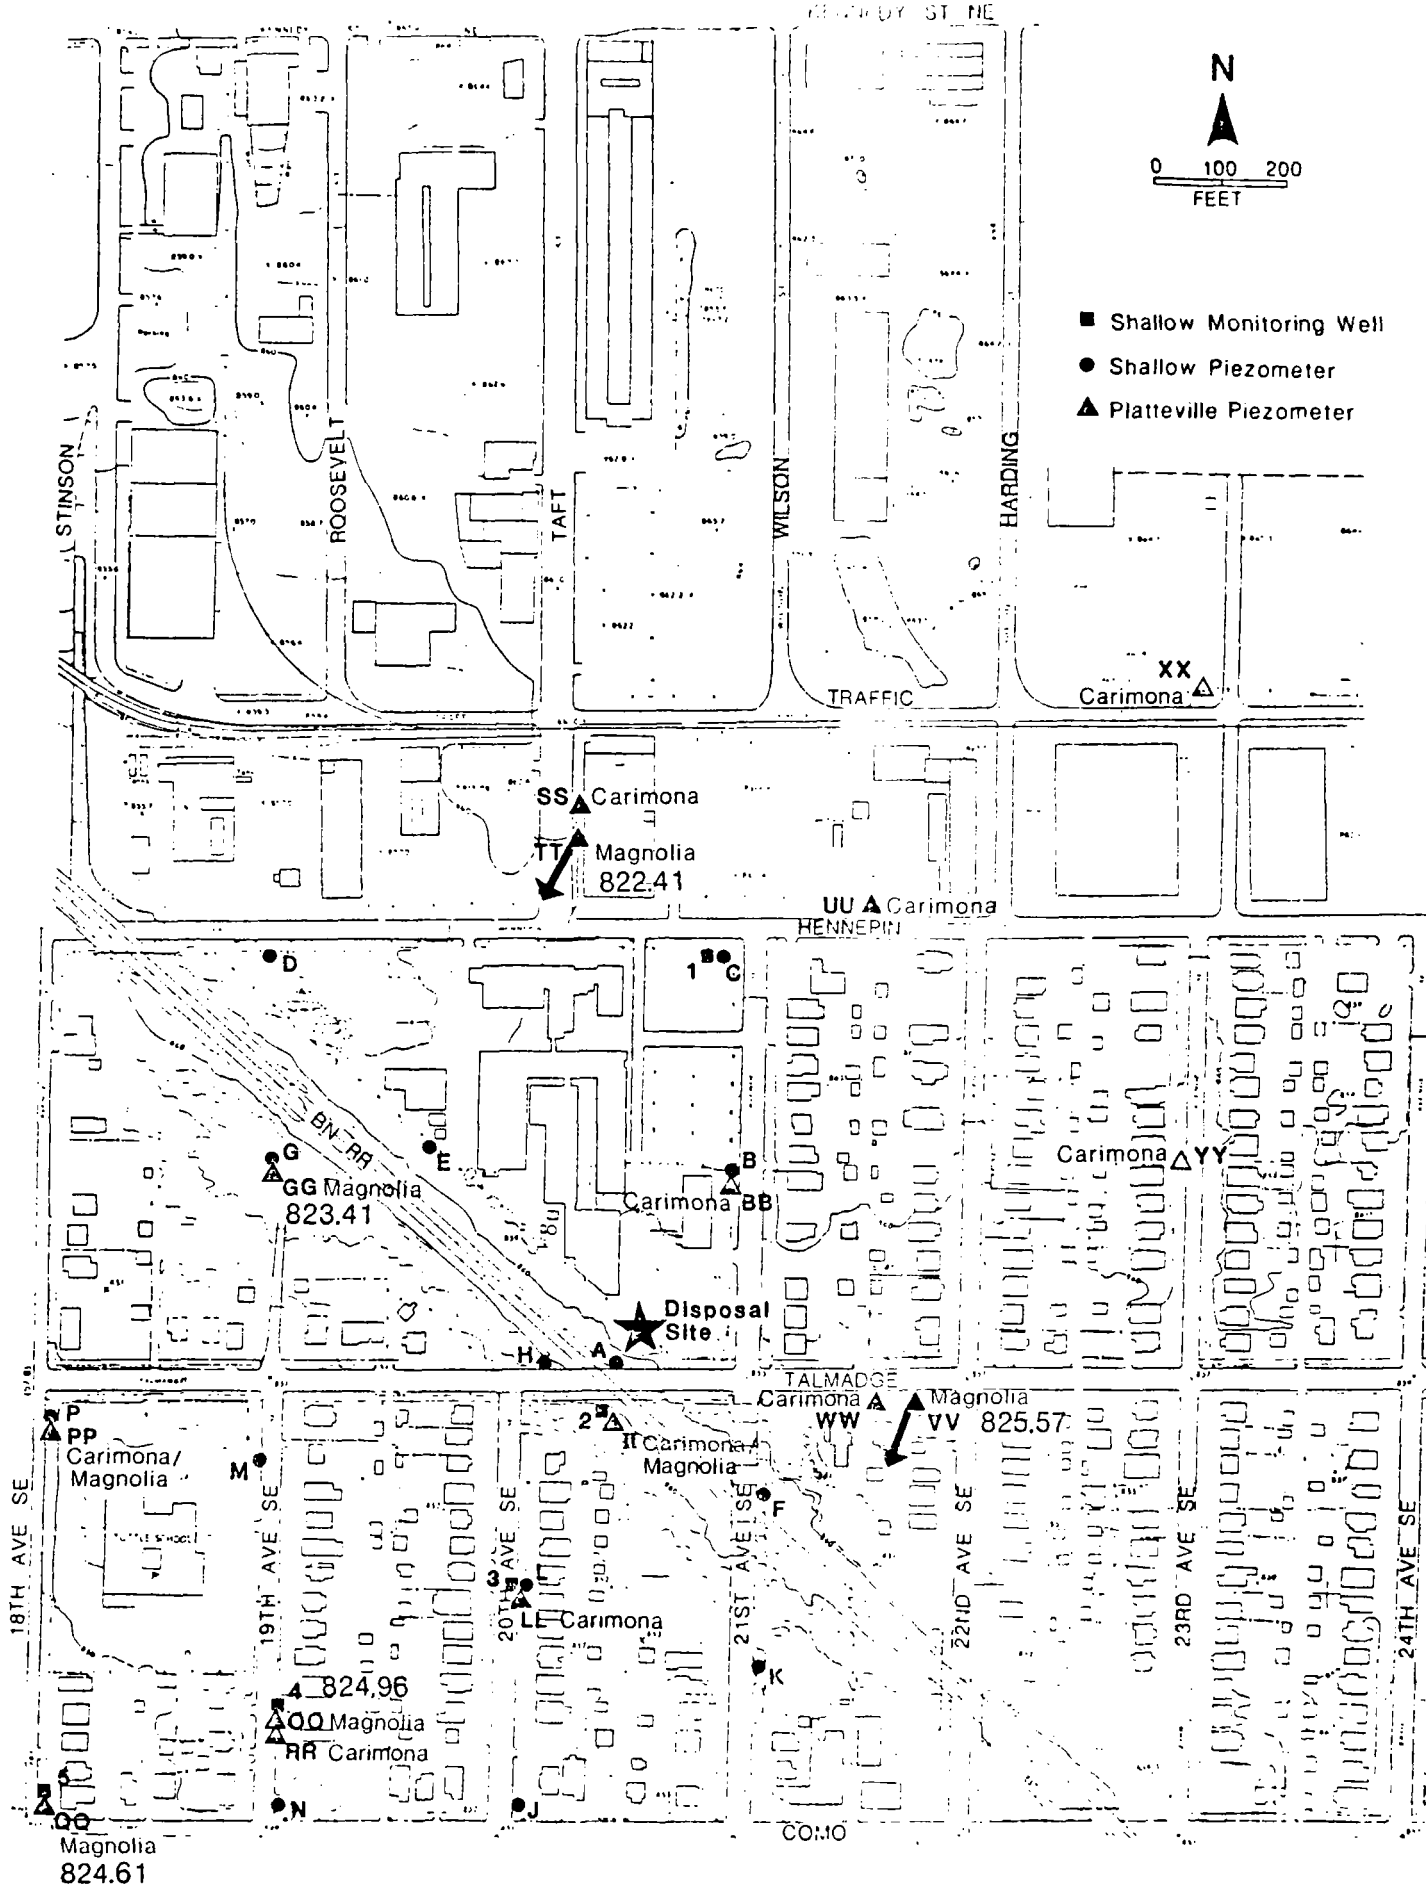
Figure 3

through fractured zones and solution channels. For this reason groundwater level measurements cannot be used to determine the direction of groundwater movement with any confidence.

WATER LEVELS (MSL)
MAGNOLIA MEMBER
(November, 1982)

Direction of Groundwater Movement
Detected by Geoflow
